CONSTRUCTION STORMWATER GENERAL PERMIT INSPECTION REPORT

State of Washington Department of Ecology

Ecology Inspector(s): Carol Serdar	On-Site Representative Name: Thom Fischer Title: Electron Hydro LLC, permittee	Inspection Date and Entry/Exit Time: 21 Sept 2020, 9:00/14:00	Inspection Type: ERTS and CSWGP review
Contaminated CSWGP Inspector Phone: 360.742.9751 Email: carolserdar@ecy.wa.gov	Additional Participants:	Receiving waters: Puyallup River	Permit webpage: https://fortress.wa.gov/ecy/p/aris/FacilitySummary.aspx?FacilityId=70091

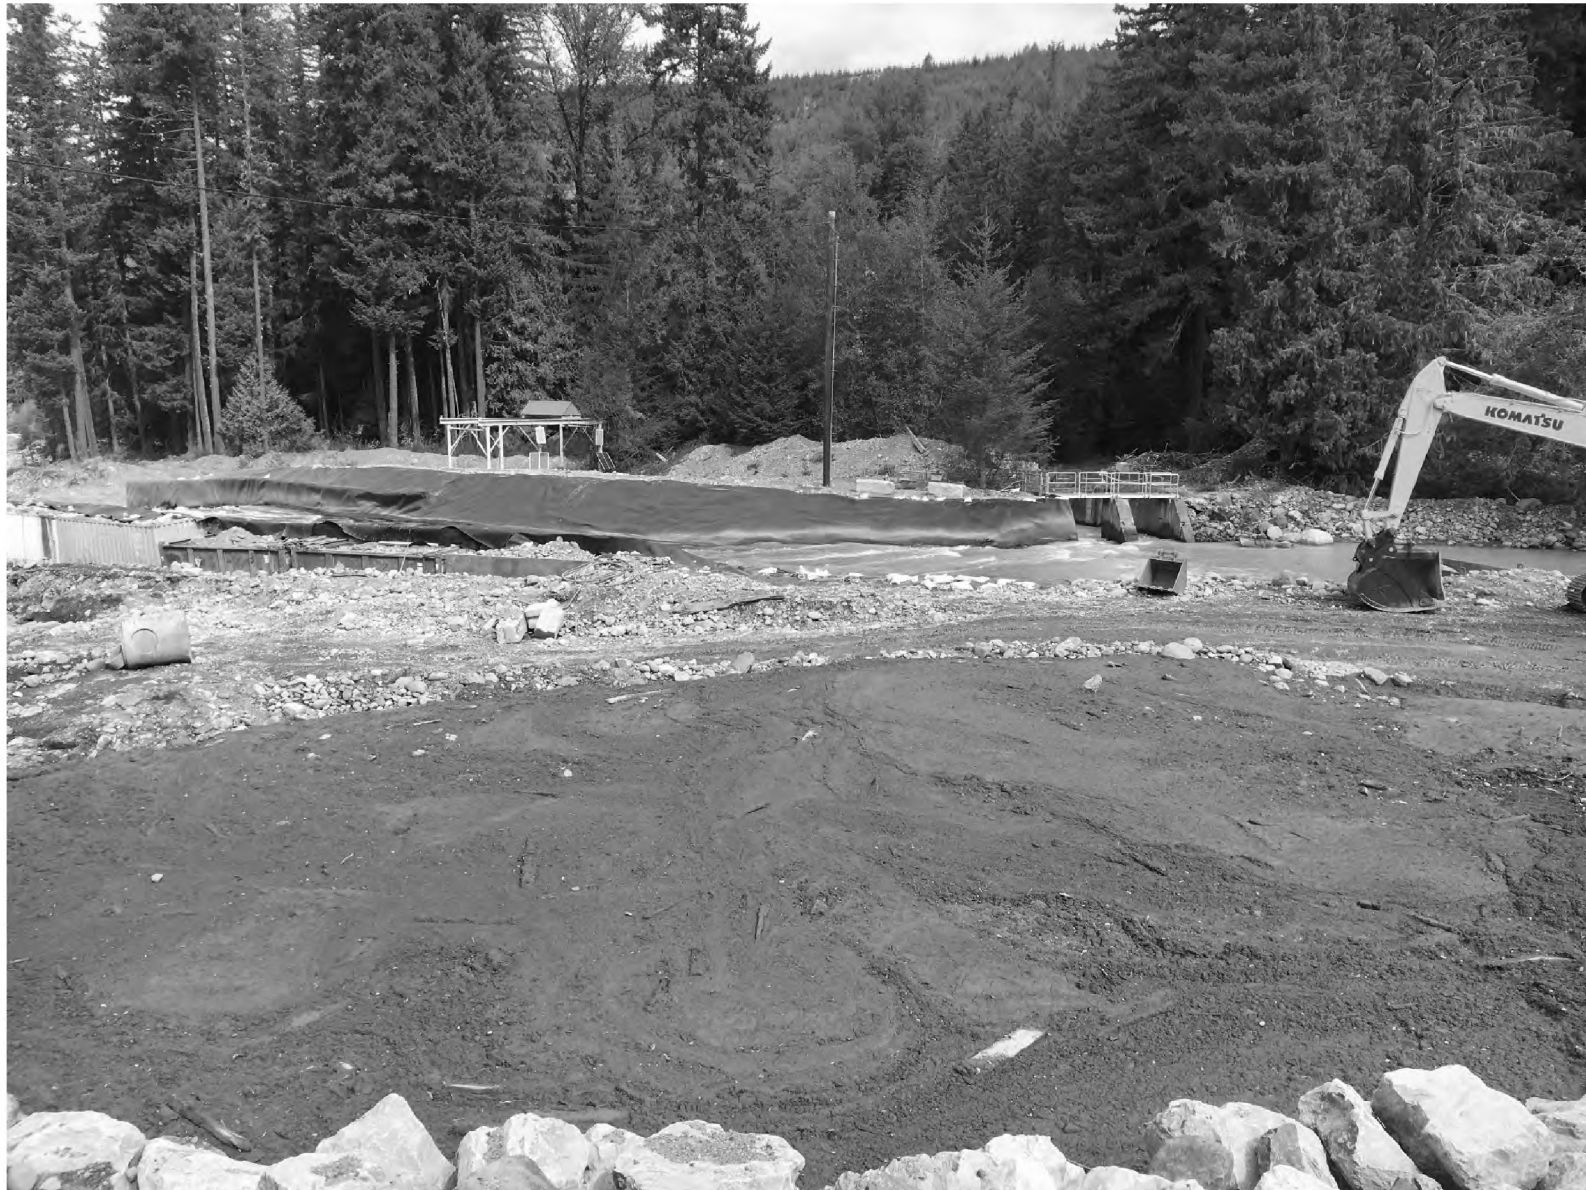
Photo 25

Photo Description: Intake Structure Construction area – upstream portion of construction area; fish ladder entrance and by-pass channel in black liner (turf below black liner).

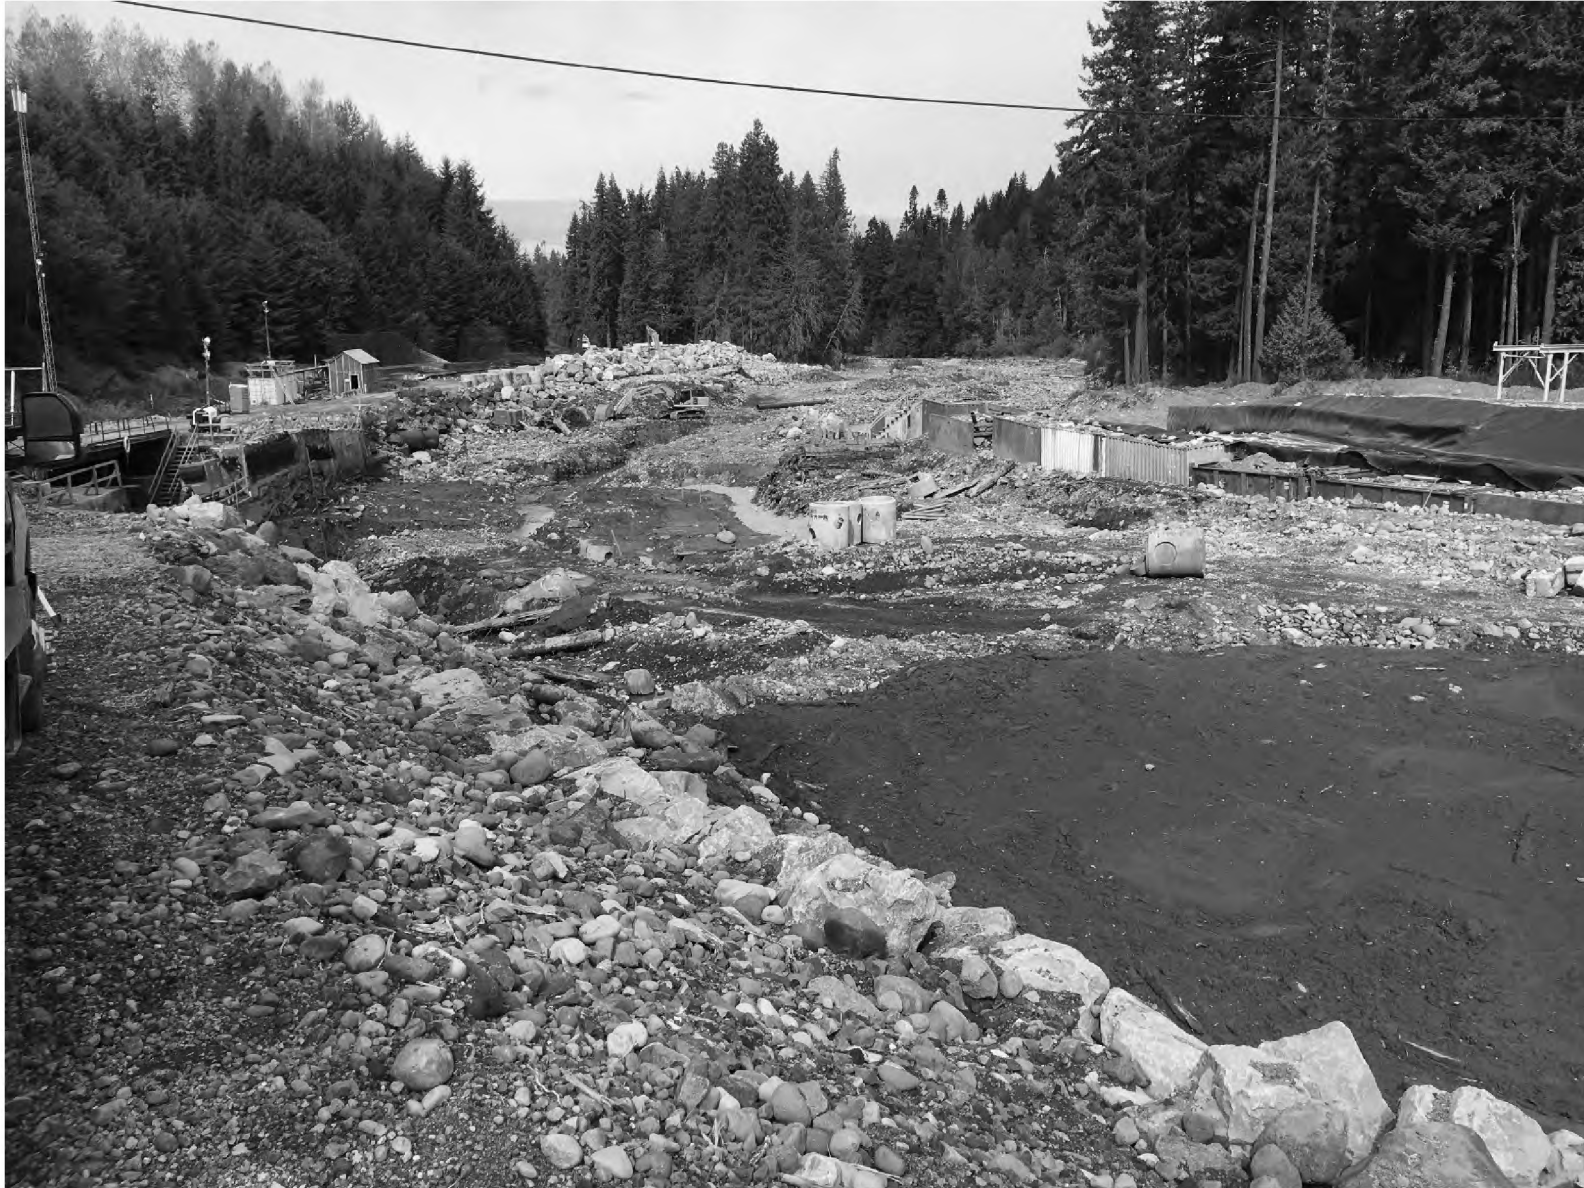
Photo 26

Photo Description: Intake Structure Construction area – looking downstream, intake structure on left and river is within black liner on right.

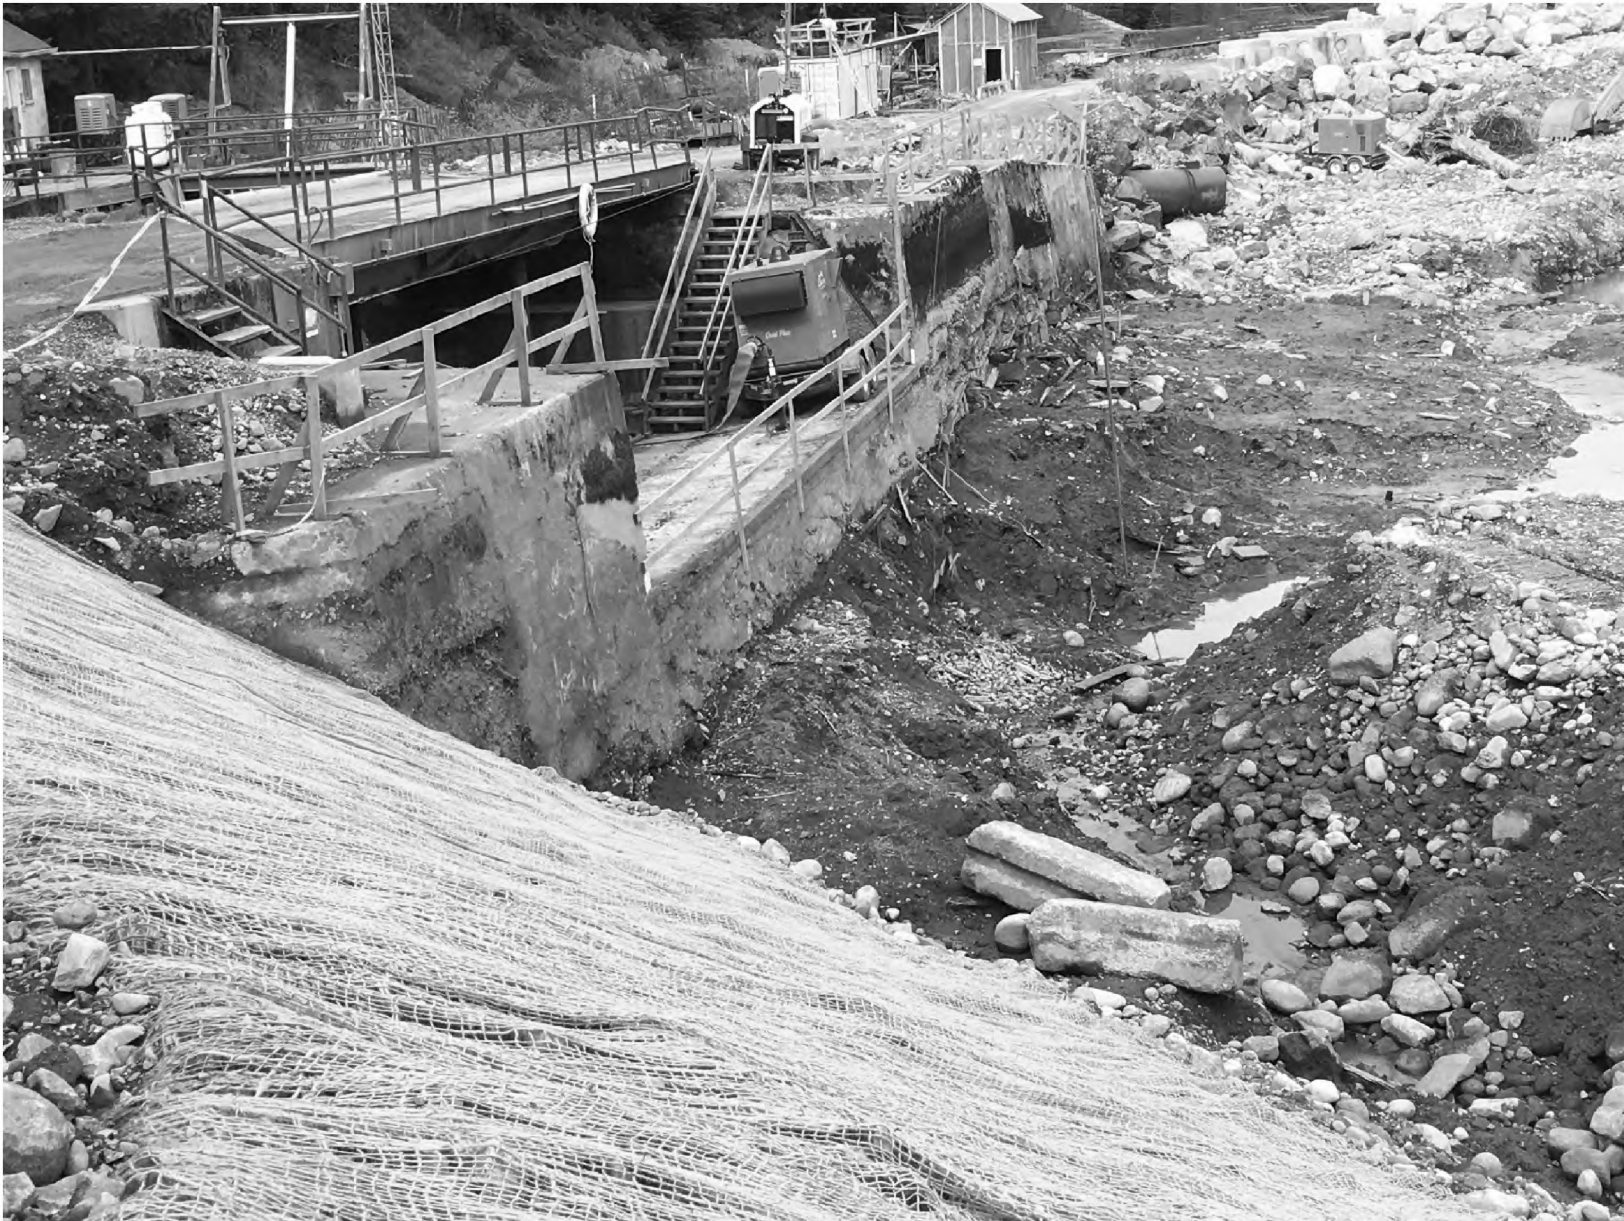
Photo 27

Haul road has been stabilized with gravel; adjacent slope to the intake structure had been previously exposed and unworked, has been stabilized with jute mat; discussed potential for need of additional BMP if stormwater rills the slope. Survey work of river bed was in progress. Discussed movement of rock and sediment used in construction around the site.

Photo Description: Intake Structure Construction area – jute matting on previously exposed and unworked soil; discussed there may be a need for additional BMPs.

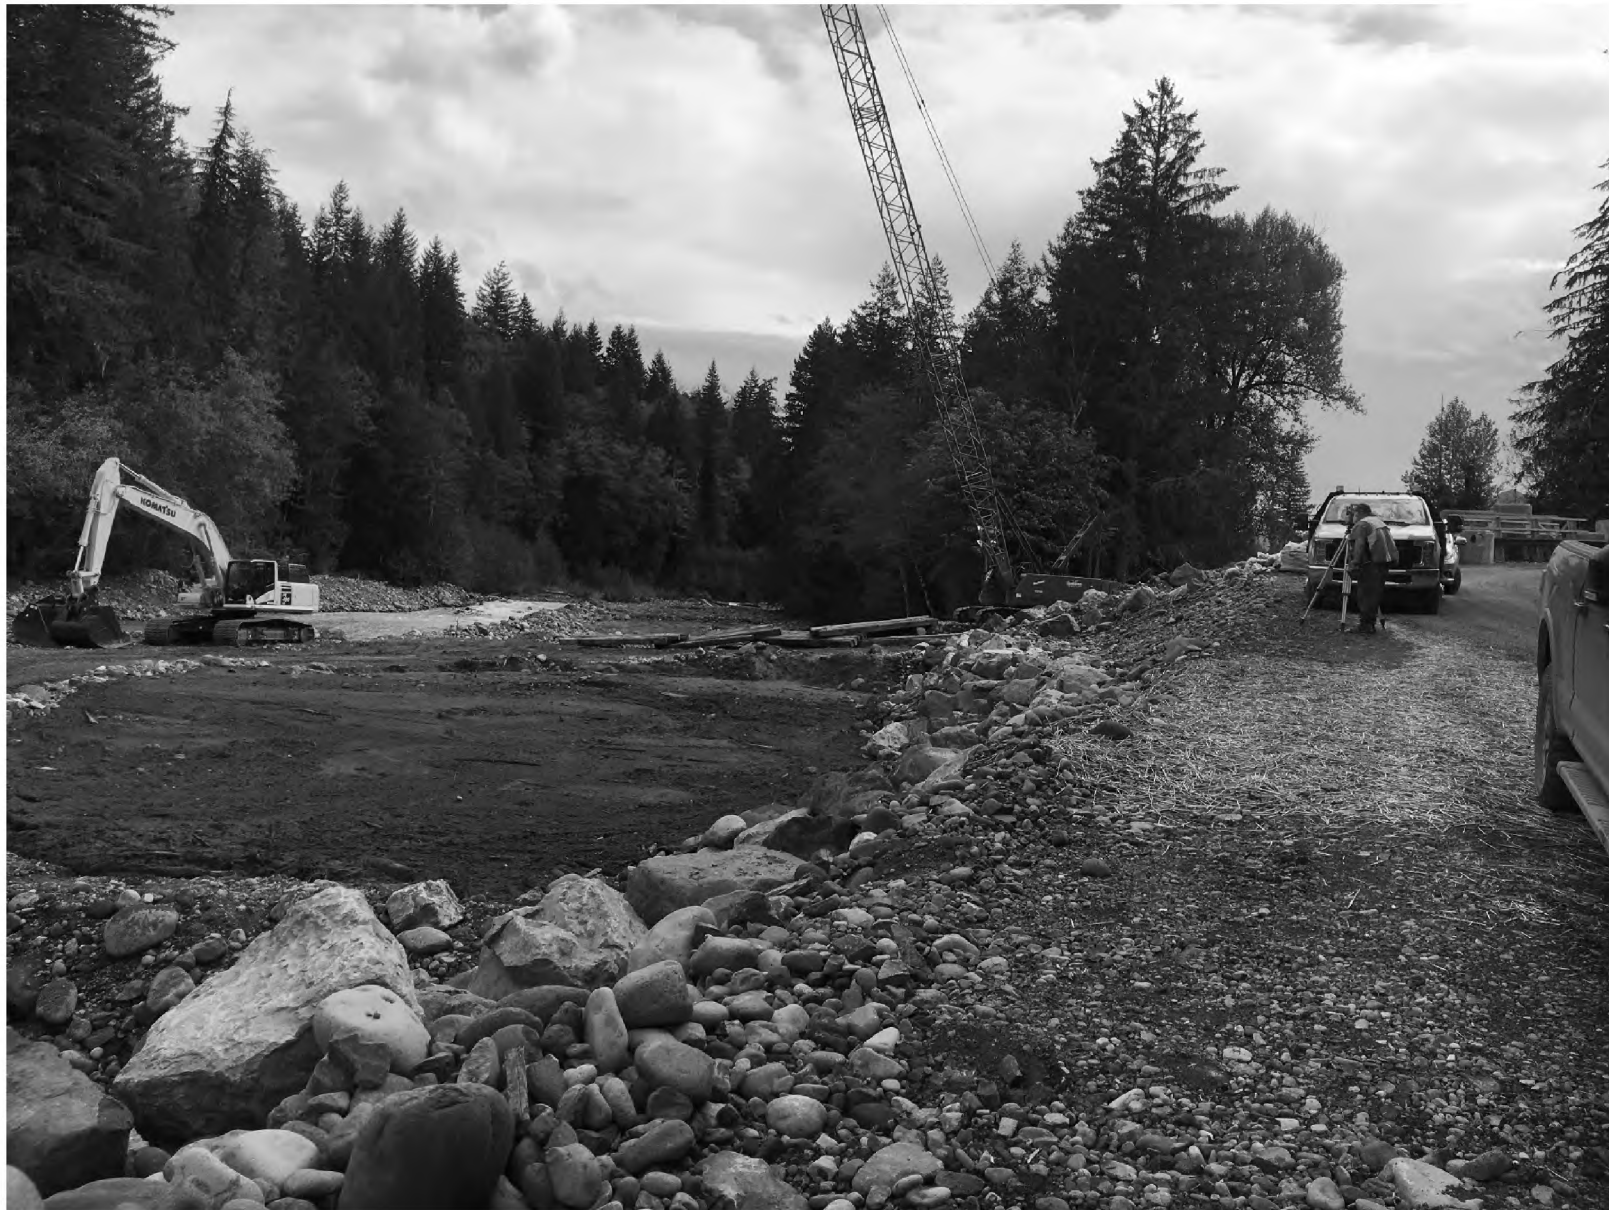
Photo 28

Photo Description: Intake Structure Construction area – upstream construction area; survey of streambed.

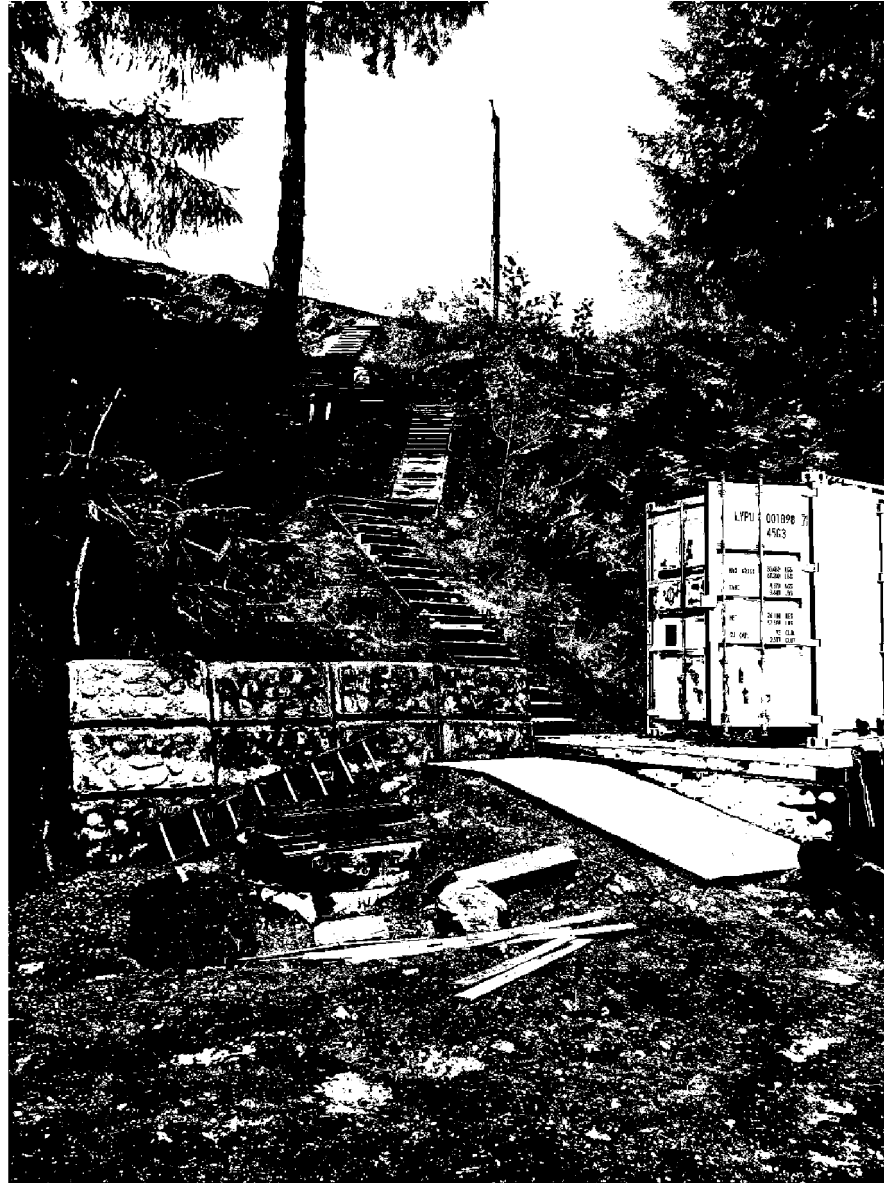
Photo 29

Concrete stairs had been poured, and exposed and unworked soil on steep slope is now stabilized.

Photo Description: Intake Structure Construction area – concrete stairs had been poured, slope now stabilized.

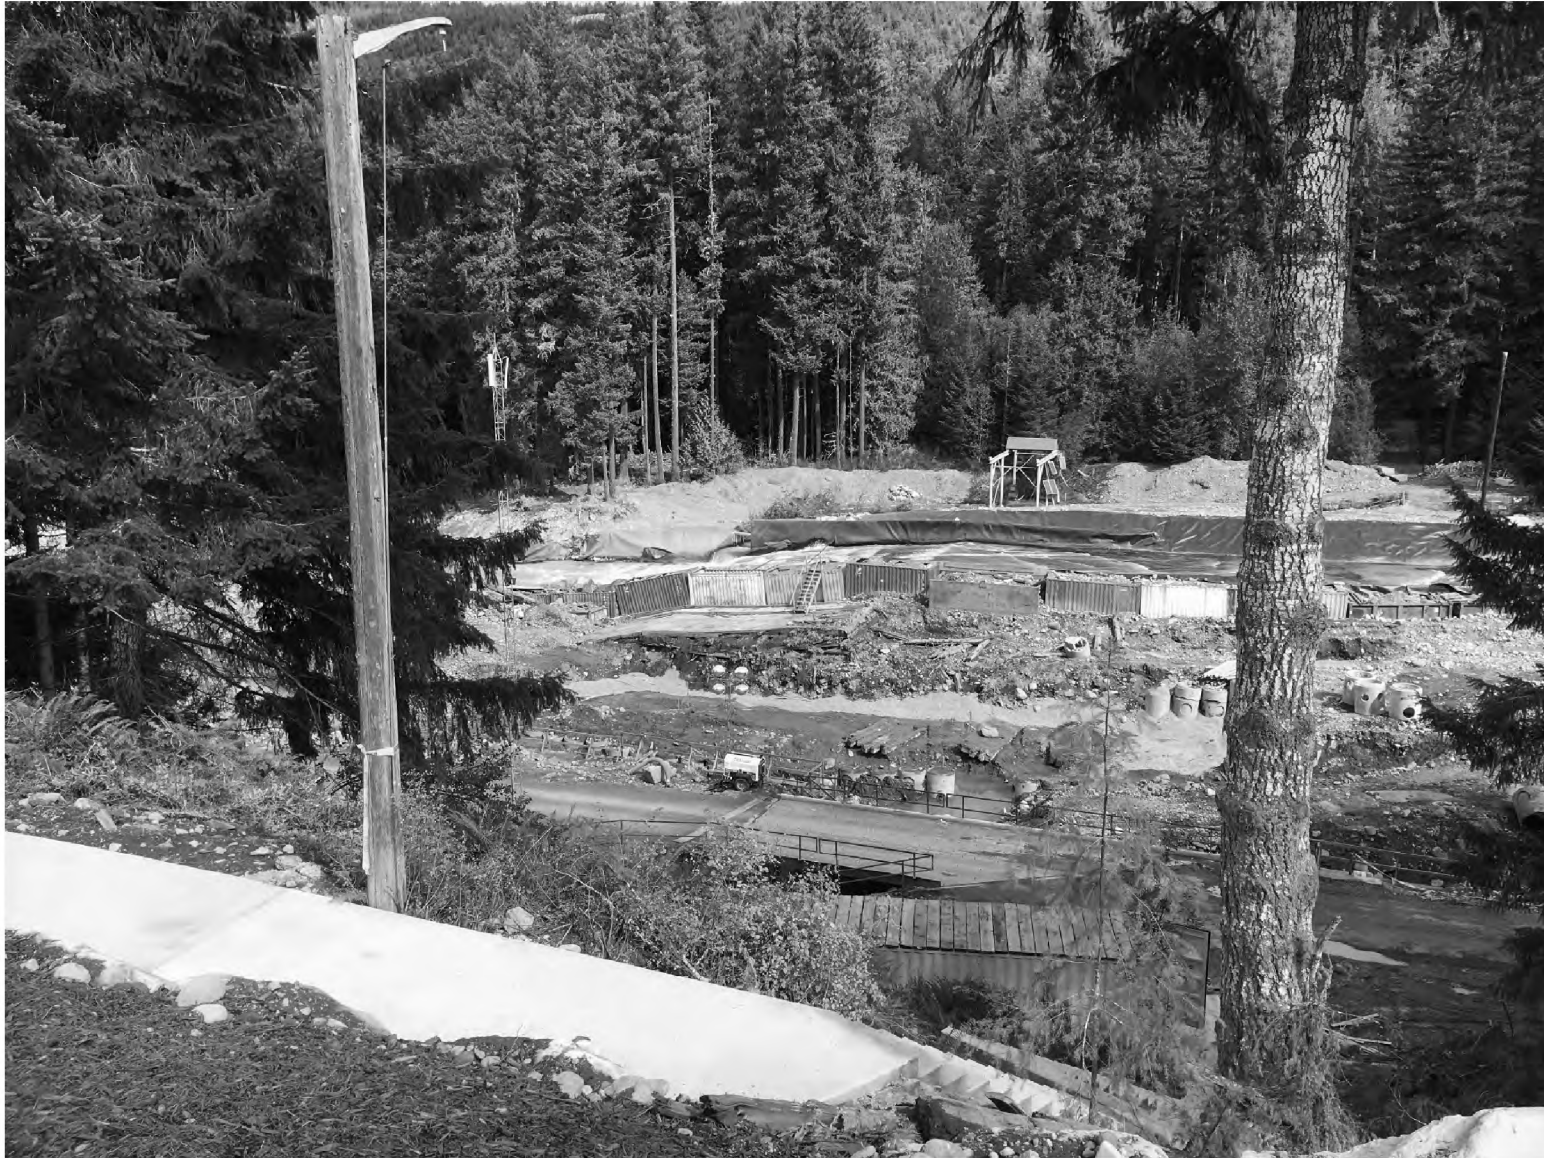
Photo 32

Photo Description: Intake Structure Construction area – concrete stairs have been poured and area stabilized; note by-pass channel in black liner, some slumping of soil below the black liner may be occurring along the right bank, downstream of fish ladder entrance.

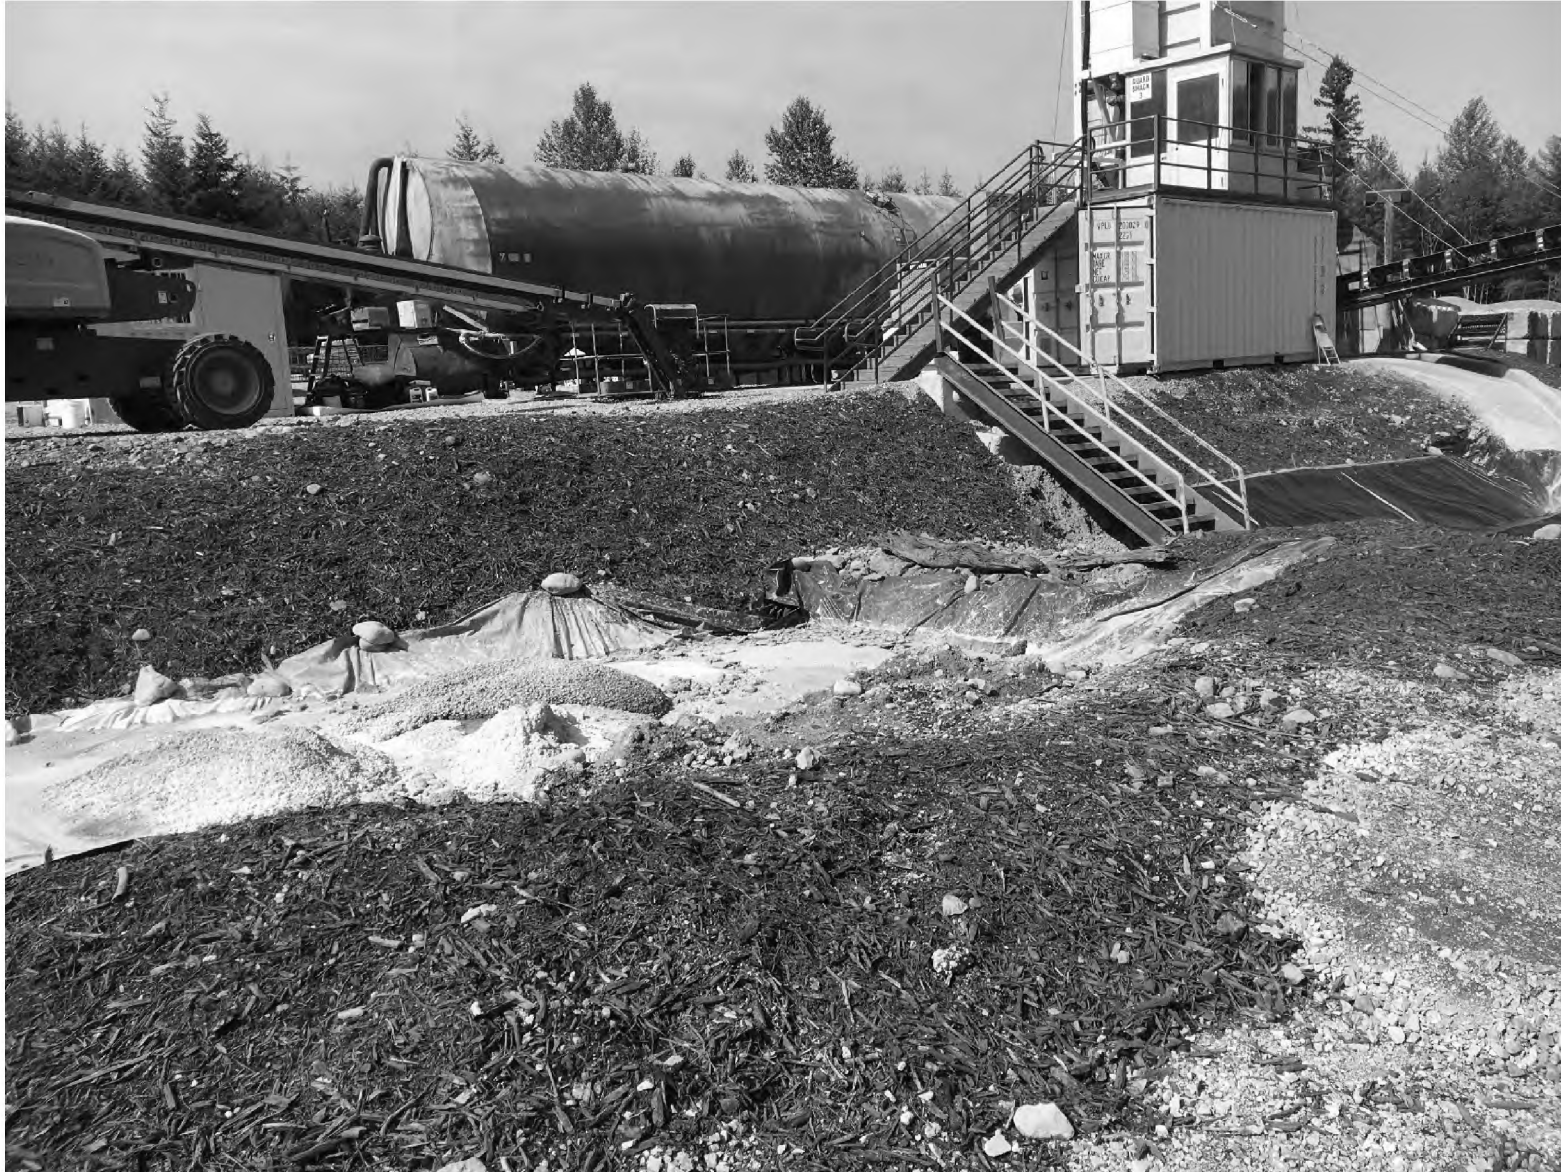
Photo 33

Photo Description: Intake Structure Construction area – concrete wash area, no discharge from area.

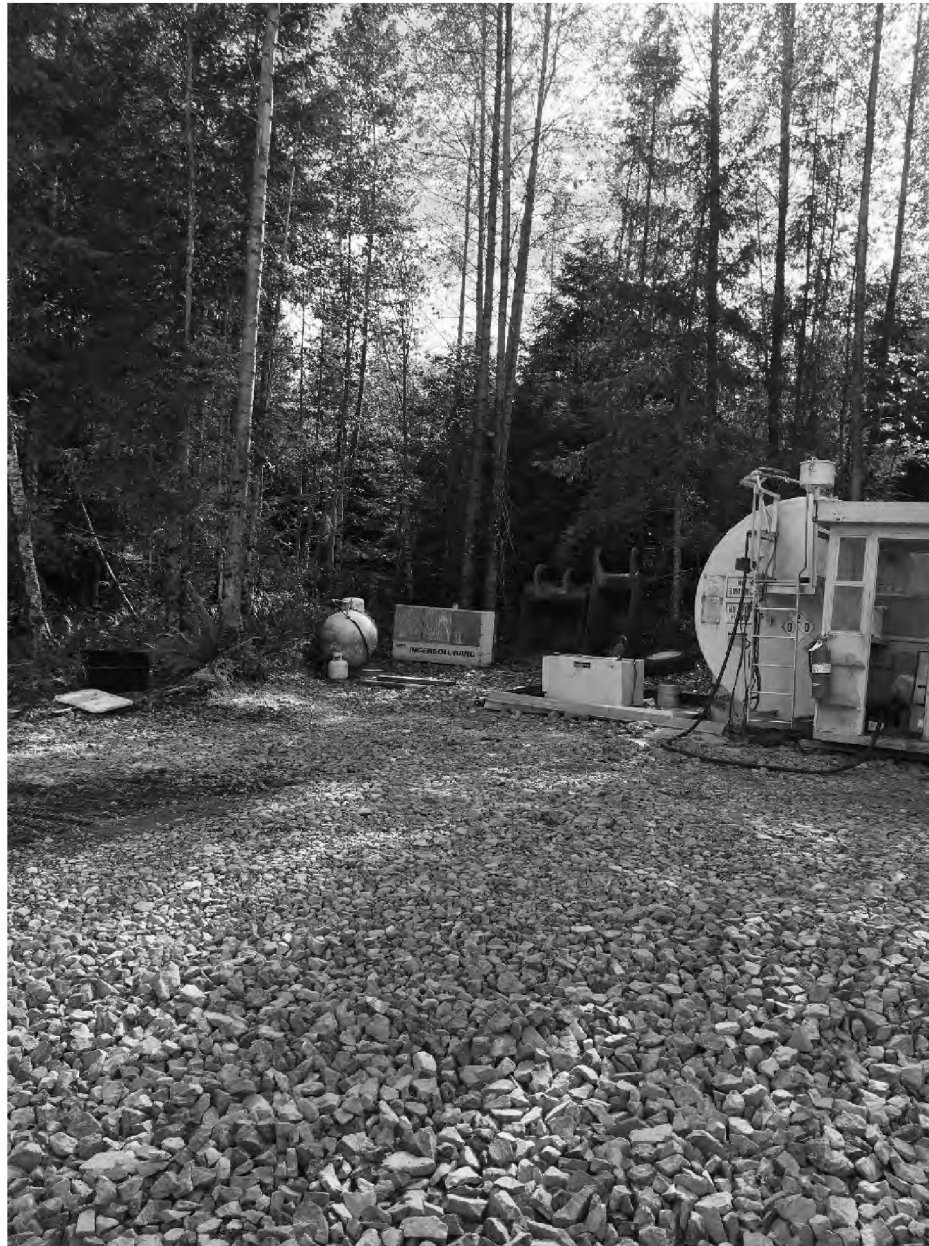
Photo 34

Photo Description: Intake Structure Construction area – secondary containment.

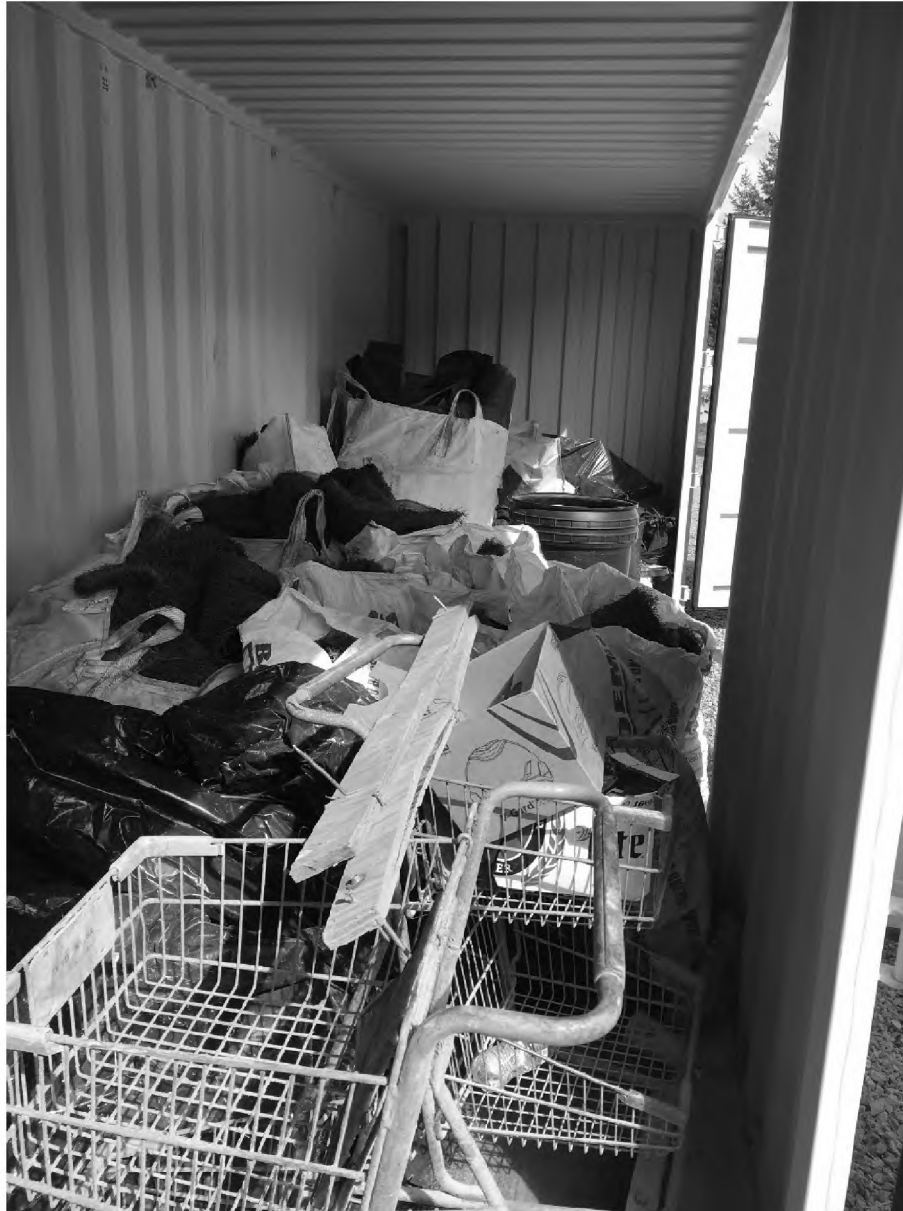
Photo 35

Photo Description: Electron Hydro Office parking lot area – conex box with debris removed from the river (more than sports turf).

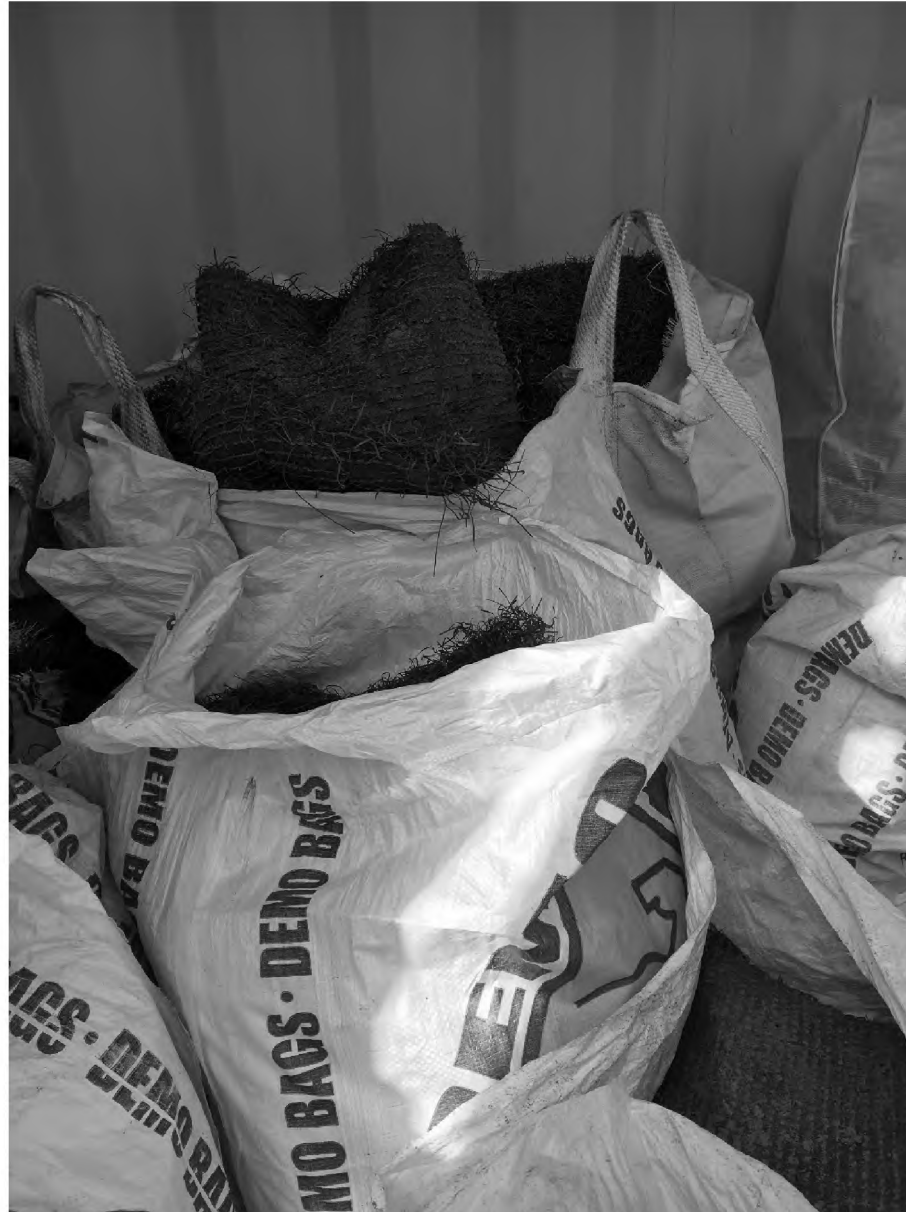
Photo 36

Photo Description: Electron Hydro Office parking lot area – conex box with debris removed from the river, sports turf in super sacks and plastic bags.
